Inspection and structural health monitoring techniques for concentrated solar power plants

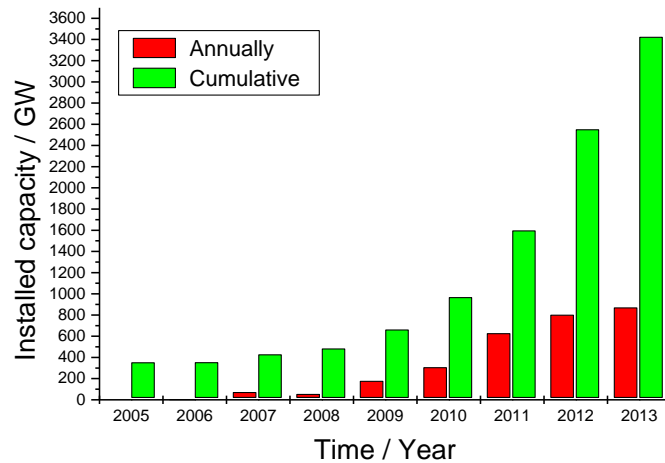
Figure 1: Global cumulative installed CSP capacity [5].

The graph in Figure 1 shows the global cumulative installed CSP capacity by the end of 2014 [5]. The uptake and track record of CSP technologies up until the end of 2013 is shown in Figure 2. Parabolic trough CSP is the most established technology in terms of installed capacity.

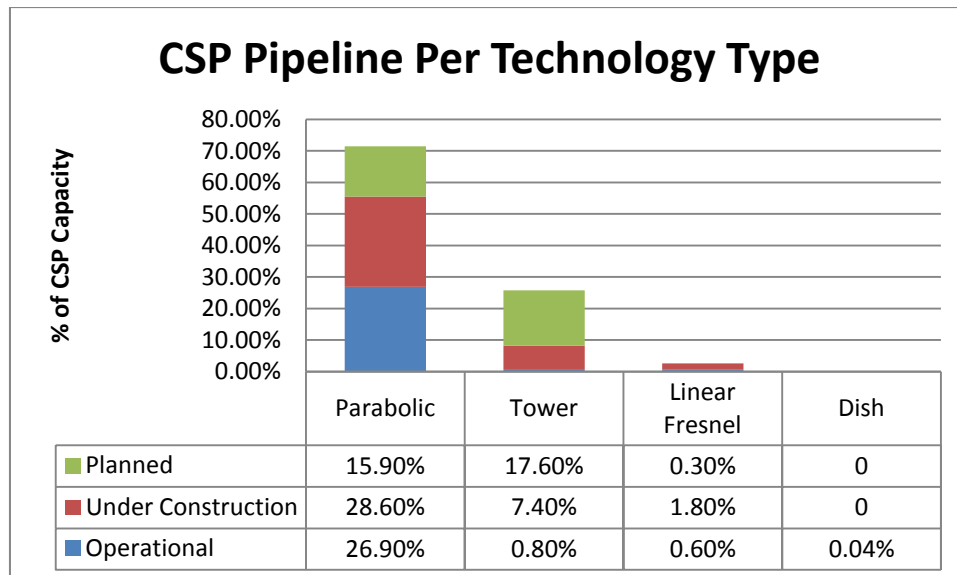
Figure 2: Implementation of CSP technologies as of 2013 [6].

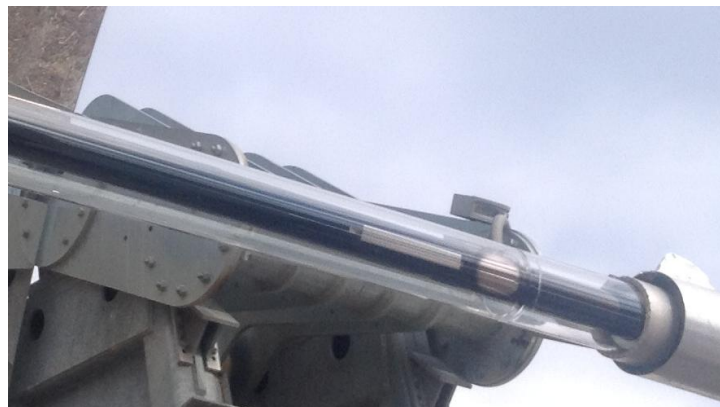
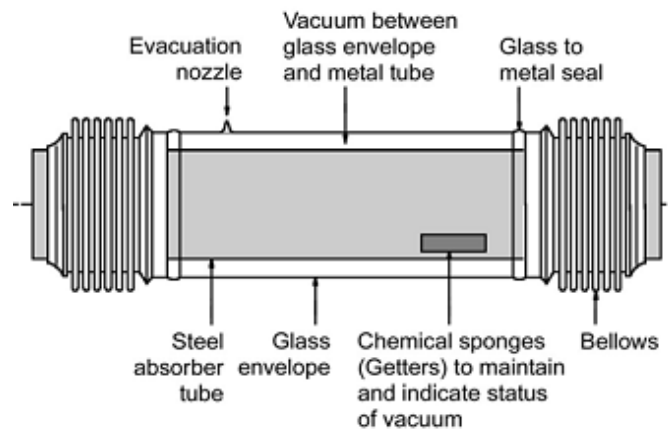
Figure 3: Typical solar absorber tube used in parabolic trough and LFR CSP plants.
[schematic taken from reference 7].

6 Solar absorber tubes operate under very harsh conditions. CSP plants make use of a wide
7 range of materials for the manufacture of key structural components including plain carbon
8 steels (cold storage tanks and secondary piping) and stainless steels (solar absorber tubes,
9 valves, primary coolant system piping, hot storage tanks and pumps). The schematic in figure
10 3 shows the main features of a typical solar absorber tube.

18 The thickness and diameter of solar receiver tubes needs to be optimised to ensure the
19 efficient heating of the working fluid. Typical commercial solar absorber tubes are
20 manufactured of austenitic stainless steel grades such as 304L, 316Ti or 321H with an overall
21 length of 4 m per section which are then welded together using precision orbital Tungsten
22 Inert Gas (TiG) welding [8-10]. The typical diameter of the solar absorber tube is 70 mm.
23 The wall thickness of the solar absorber tube depends on the working fluid employed.
24 Normally, 1.5-3 mm wall thickness is employed for oil and molten salt-based operation and
25 4-6 mm for DSG. The higher wall thickness is required in DSG to withstand the higher
26 pressures involved during operation. Bellows welded using automated electron beam welding

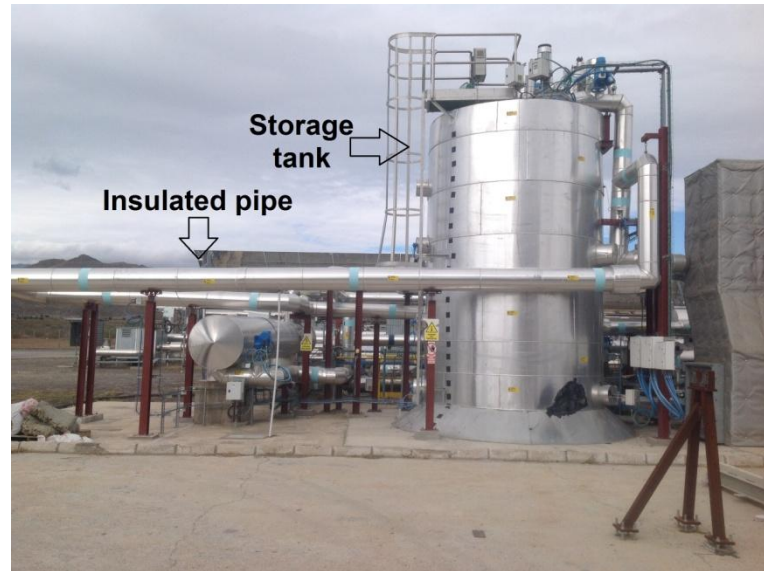
Figure 4: The photograph shows insulated pipelines and a molten salt storage tank at PSA, Tabernas Desert, Spain.

34
35
36 In CSP plants the coolant system piping is insulated to minimise heat losses during plant
37 operation as shown in Figure 4. Therefore inspection can only be carried out only after
38 removing the insulation which is a very time consuming and expensive process.

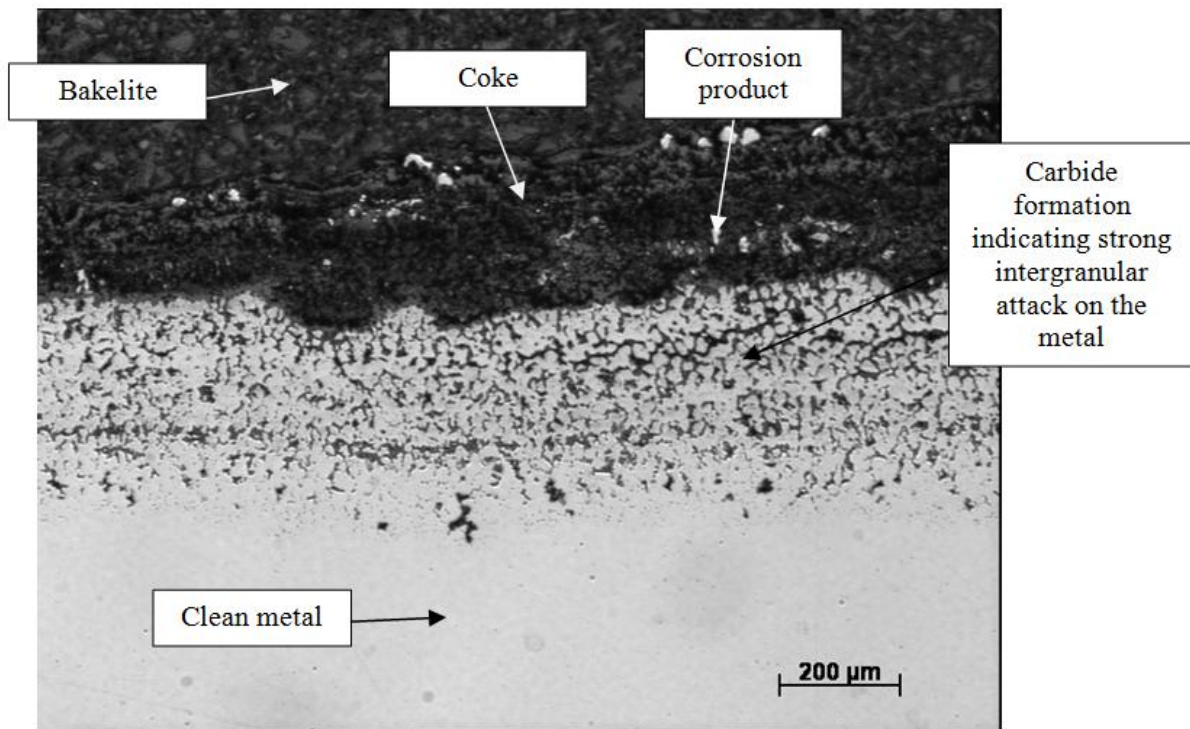
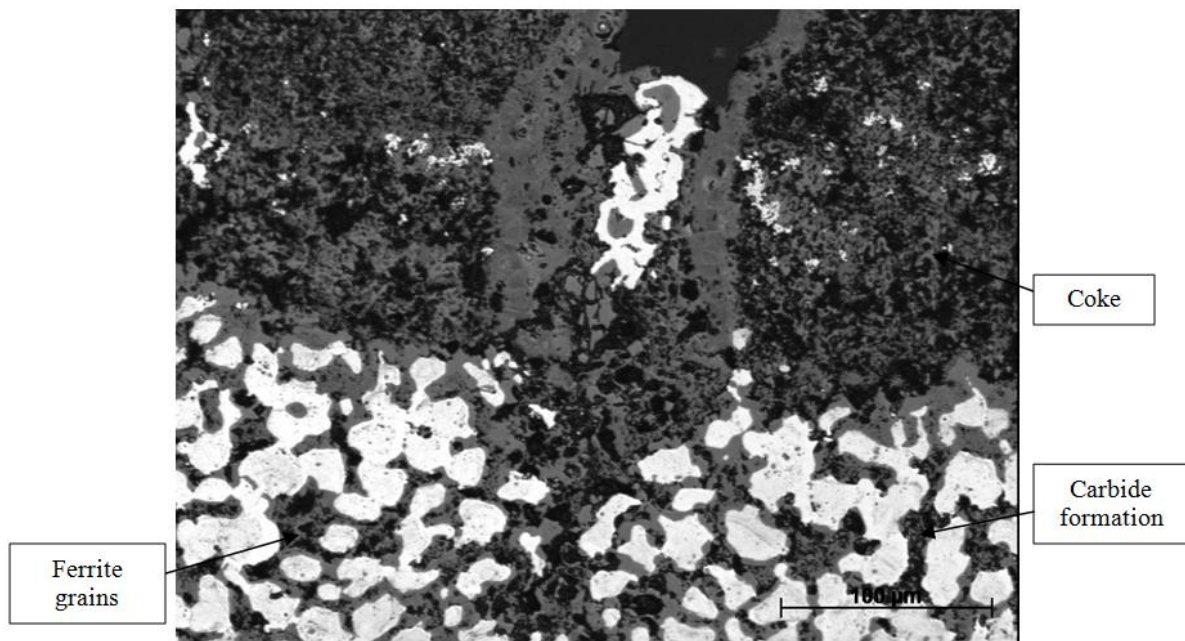
Figure 5: Metal dusting of a P5 pipe carrying oil.

29 Metal dusting is a corrosion mechanism which affects stainless steels operating at
30 temperatures between 300-850 °C under carbon-supersaturated gaseous environments [23-
31 28]. Oil is currently the most common working fluid in CSP plants which operate between
32 300-400 °C. The use of oil as working fluid can result in carbon (coke) accumulating on tube
33 and pipe sections. Metal dusting once it initiates will cause significant wall thickness
34 reduction which can eventually result in failure. The micrographs in Figure 5 demonstrate an
35 example of metal dusting on a P5 pipe carrying oil. Hochman et al. [24] revealed the effect of
36 M_3C metastable carbide in the initiation of metal dusting. Grabke et al. [25-26] investigated
37 further the formation and dissociation mechanisms associated with the M_3C carbide and the
38 break-up of surface oxide films in initiating local attack.

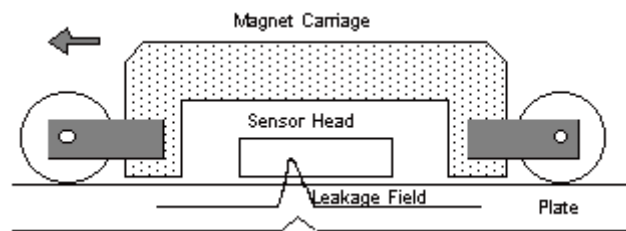
Figure 6: Schematic showing the principle of MFL [schematic taken from reference 35].

Strong rare earth magnets are used to magnetise the component inspected as shown in Figure 6. If a component is free of defects the magnetic flux lines will be retained within the walls of the component. However, in the case where a defect is present some of the magnetic flux will leak. The amount of flux that will leak depends on the defect size (depth, width and length), orientation, geometry as well as the level of magnetisation achieved. The variations occurring in the induced magnetic field due to the magnetic flux leaking can be detected by an array of magnetic field sensors such as a sensing coils, Hall Effect sensors, Giant Magnetoresistance (GMR) probes or fluxgate sensors and can be related to the severity, geometry and defect [38-39]. The whole circumference of a pipe can be magnetised during inspection thus simplifying and speeding up the whole process. The spacing between adjacent sensing elements in the array must be small enough to ensure that there are no gaps across the array affecting the detection capability of the MFL system.

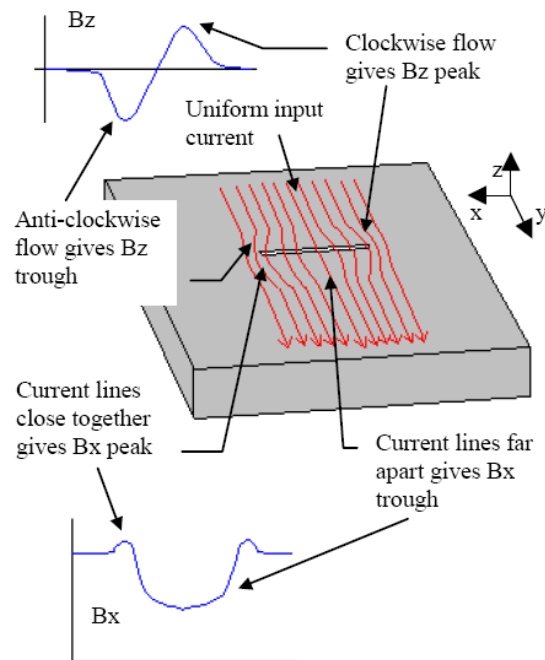
Figure 7: Definition of field directions and co-ordinate system used in ACFM [taken from reference 52].

Alternating Current Field Measurement (ACFM) inspection shares many similarities with conventional EC testing. An induction coil brought near the surface of a conductor induces a remote uniform alternating current field on the thin skin of the component being tested. As a result of the uniform alternating current field a magnetic field will also be generated. If there is no defect present then the AC field will remain undisturbed. However, in the presence of a defect the induced AC field will be disturbed with some of the current lines flowing around the edges of the defect and some below it. The changes in the AC field will subsequently result in variations to the associated magnetic field which can be detected using sensing coils orientated in the X and Z direction with respect to the surface being inspected. Any changes in the signal associated with the coil orientated in the X direction will be related to the depth of the defect whilst any changes associated with the coil orientated in the Z direction will be related to its length [52]. The principle of ACFM is shown in Figure 7.

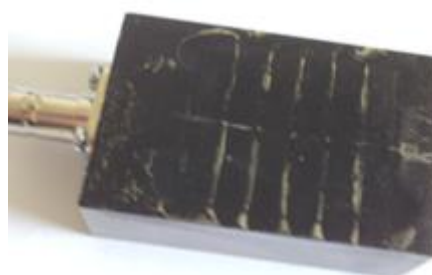
34
35 Figure 8: Photograph of one the EMATs used in the INTERSOLAR project. The EMAT was
36 manufactured by SONEMAT Limited in the UK.

27 Within the INTERSOLAR project (www.intersolar-shm.com) an EMAT LRU system is
28 currently being evaluated for the inspection of in-service solar absorber tubes and insulated
29 pipes. The system is currently undergoing testing under laboratory conditions following
30 completion of the numerical modelling using COMSOL. The shear horizontal EMAT used
31 for the experimental work have been manufactured by SONEMAT Limited in the UK and are
32 shown in Figure 8.

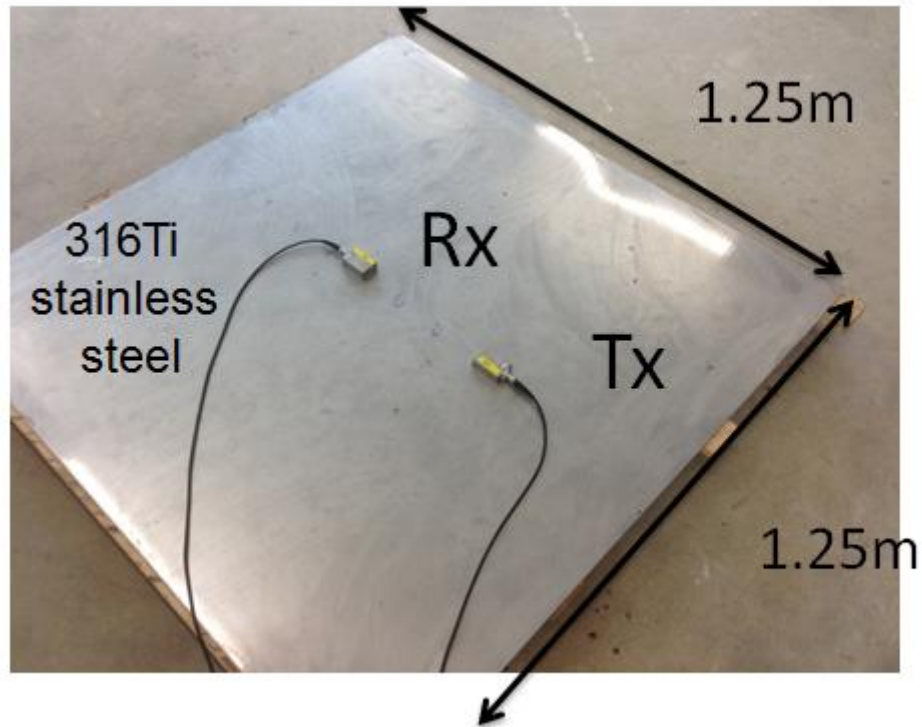
Figure 9: EMATs working in pitch-catch mode mounted on a calibration stainless steel plate.

During initial evaluation trials two EMAT transducers, operating in pitch-catch mode have been mounted on a 3 mm-thick 316Ti stainless steel plate used for calibration tests. The steel grade chosen is the same grade as the one used for manufacturing absorber tubes. The photograph in Figure 9 shows the experimental set-up employed.

Various artificial slot type defects simulating cracks were induced in the calibration plate. The artificially induced slots had depths from 0.5 mm to 2 mm and lengths from 13 mm to 20 mm. The EMAT transmitter was driven using a RITEC RAM-5000 system. The excitation current was modulated using a Hanning window at 256 kHz with 6 cycles and 1200 V peak-to-peak voltage.
